## Unsichtbare Kristalle und Atemreglerausfälle

## **POLYMORPHIC CRYSTALLISATION' IN 'NYLON-BRAIDED' HOSES**

### **AN IMPORTANT BUT 'INVISIBLE' CAUSE OF SECOND-STAGE SCUBA REGULATOR FAILURES**

## Invisible Crystals

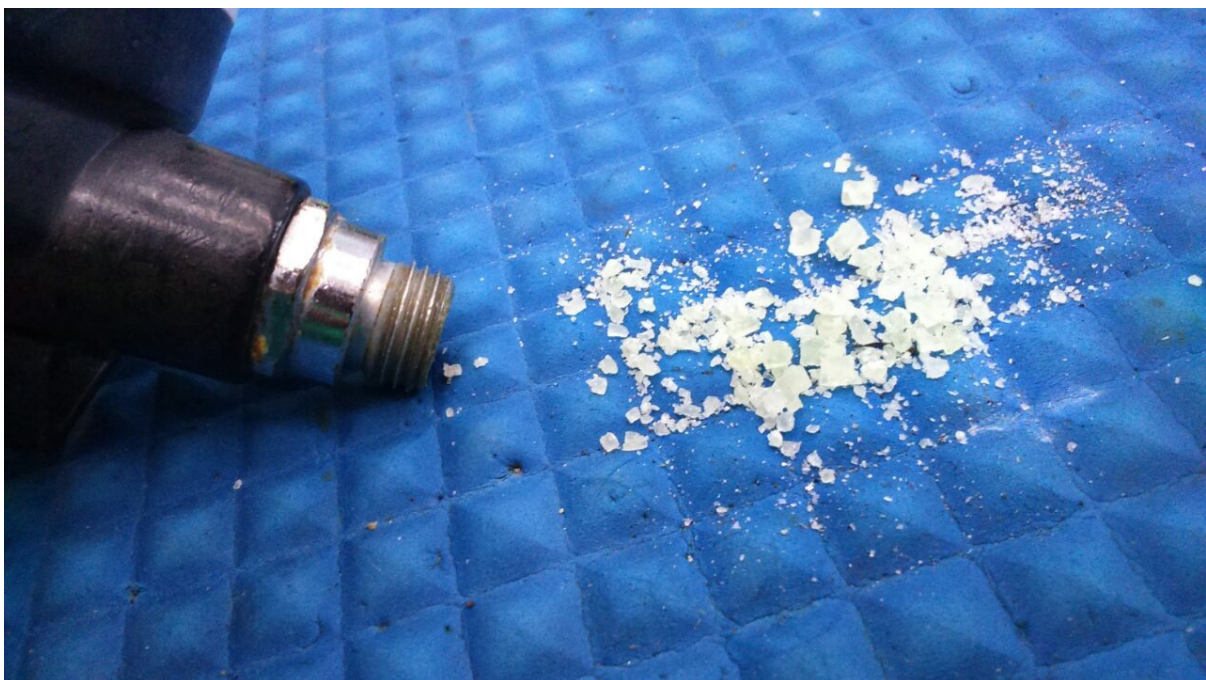
Obwohl die in den Vorfall verwickelten Taucher die Situation sehr gut im Griff hatten und niemand zu Schaden kam, hätte ein unerfahrener oder nervöser Taucher vielleicht nicht so viel Glück gehabt. Besonders bemerkenswert war, dass die Flasche des Tauchers nicht leer war, das Atemgas aber immer langsamer ausströmte und schließlich wie in einer Out-of-air Situation ganz versiegte. Die genauere Untersuchung der Ausrüstung führte zu einer rätselhaften Entdeckung: eine große Menge an gelbem „kristallisiertem“ Material verstopfte die Innenseite des Einlaßventils der zweiten Stufe. Das Material schien aus dem Inneren des Schlauchs zu kommen, der zwar schon ein paar Jahre in Gebrauch war, aber äußerlich keine Unregelmäßigkeiten oder Abnutzungserscheinungen zeigte.

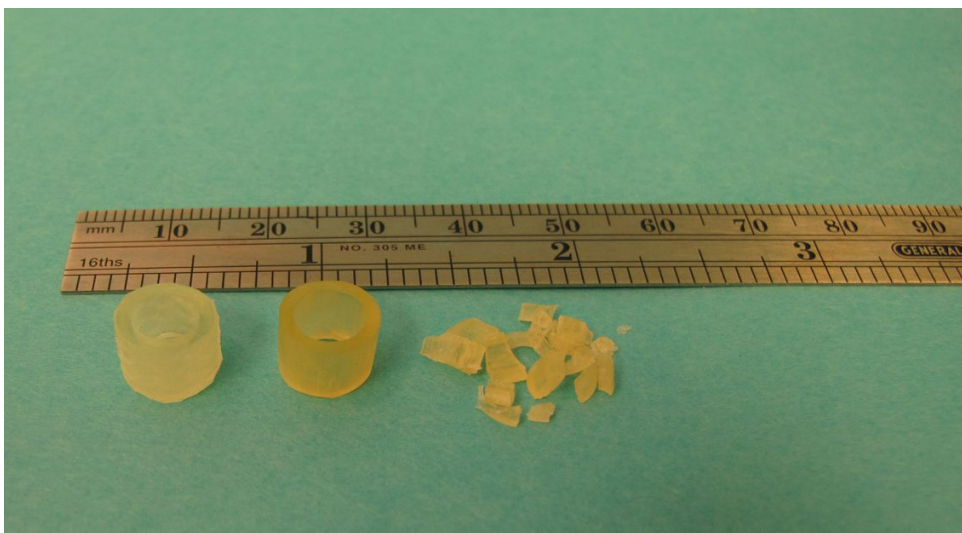
Ein begeisterter Taucher, Ingenieur bei einem privaten Unternehmen in den USA, bot an, Niederdruck-Gewebeschläuche einer gründlichen Prüfung zu unterziehen. Er ließ verschiedene Schläuche auf künstlichem Weg schneller altern und fand zunächst einmal heraus, dass Schläuche mit einem Innenmaterial aus thermoplastischem *Polyester*-Polyurethan (Polyester-TPU) während der Untersuchung zerfielen. Dieses Ergebnis entspricht auch den Berichten, die DAN zum Thema Schlauchversagen gesammelt hat. Andererseits versagten Schläuche, die aus thermoplastischem *Polyether*-Polyurethan (Polyether-TPU) bestanden oder deren Innenseite damit beschichtet war, nicht.

Ein bekannter europäischer Hersteller von Gewebeschläuchen, der seit jeher Polyether-TPU verwendet, verlangt von seinen Materialzulieferern seit 2008, dass diese die Polyether-TPU-Innenbeschichtung bescheinigen.

Das Zerfallsprodukt, eine gelbe kristallähnliche Substanz, ist weicher als es scheint und fühlt sich an wie Wachs, wenn man es zusammendrückt. Die Reaktion, die den Zerfall verursacht, ist eigentlich Hydrolyse und für diese ist, wie der Name schon sagt, Wasser erforderlich. Eine erhöhte Temperatur fördert den beschleunigten Abbau bzw. die Hydrolyse von Polyester-TPU. Wiederholtes zyklisches Erhitzen und Abkühlen der Innenbeschichtung des Schlauchs fördert diese Form der Kristallisation bei Materialien, die entweder für eine solche Verwendung ungeeignet sind oder durch bestimmte Chemikalien oder Bakterien beeinträchtigt werden. Die Sonne heizt den Schlauch auf und dann kühlt das Atemgas die Innenseite des Schlauchs wieder ab. Dieser Prozess wiederholt sich bei jedem Tauchgang und die „Kristalle“ sammeln sich im Laufe der Zeit an. Es bilden sich schließlich genügend „Kristalle“, die den Gasfluß behindern bzw. die in Richtung des Reglers der Zweiten Stufe wandern. Das führt letztendlich zu einem schwerwiegenden Ausfall des Atemgeräts.

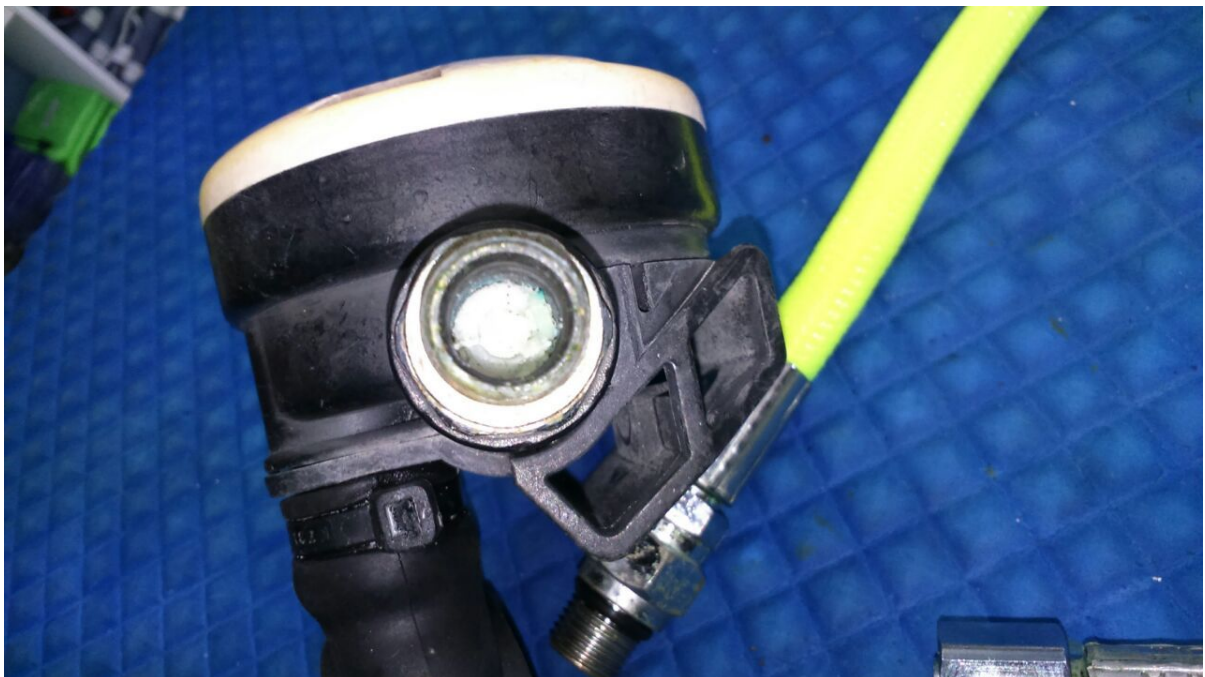
Die Standard-Sicherheitsempfehlung für Reglerschläuche lautet, dass diese regelmäßig auf Anzeichen externen Verschleißes hin untersucht werden sollten. Wenn die äußere Gummischicht zerfällt oder verschleißt, werden die Schläuche letztendlich anfällig und können reißen, wenn sie unter Druck stehen bzw. im Einsatz sind. Tatsächlich sind Gummischläuche hierfür recht anfällig, weshalb Polymer-Gewebesschläuche entwickelt wurden. Aber hier liegt das Problem: Bei einer flüchtigen Kontrolle der äußeren Oberfläche kann die Außenseite der Gewebesschläuche normal, beweglich und fehlerfrei erscheinen, während der Zerfall im Inneren unentdeckt bleibt.

- Alle Reglerschläuche, auch Gewebesschläuche, haben eine begrenzte Lebensdauer, und zwar ganz unabhängig von ihrem äußeren Erscheinungsbild, einer Verstärkung bzw. einem Schlauchschutz oder dem Gewebe selbst. Die defekten Schläuche, die wir gesehen haben, waren mehr als fünf Jahre alt.
- Beim Kauf eines Schlauchs sollte man die Zusammensetzung der Innenbeschichtung prüfen - sie sollte aus Polyether-TPU und nicht aus Polyester-TPU bestehen. Falls man

sich nicht sicher ist, sollte man den Schlauch nicht kaufen. Man sollte sein Schläuche und andere Ausrüstungsteile, die der Sicherheit dienen, von namhaften Herstellern beziehen, die eindeutig deklarieren, welches Material für die Innenbeschichtung verwendet wurde.

- Wenn es irgendwelche Anzeichen dafür gibt, dass die Gaszufuhr eingeschränkt ist, sollte der Taucher den Atemregler sofort nicht mehr verwenden. Das gilt vor allem für neuere Schläuche. Der Regler und der Schlauch müssen dann sorgfältig geprüft werden. Wenn der Regler nicht die Ursache ist, liegt es vermutlich am Schlauch.

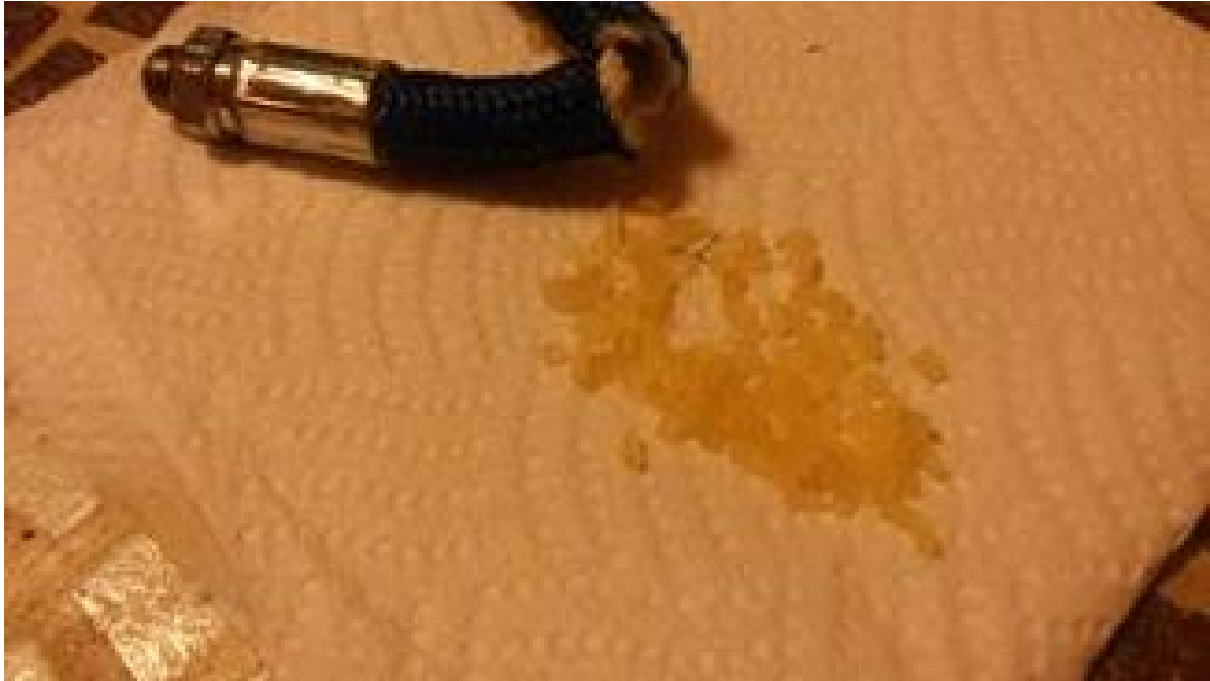
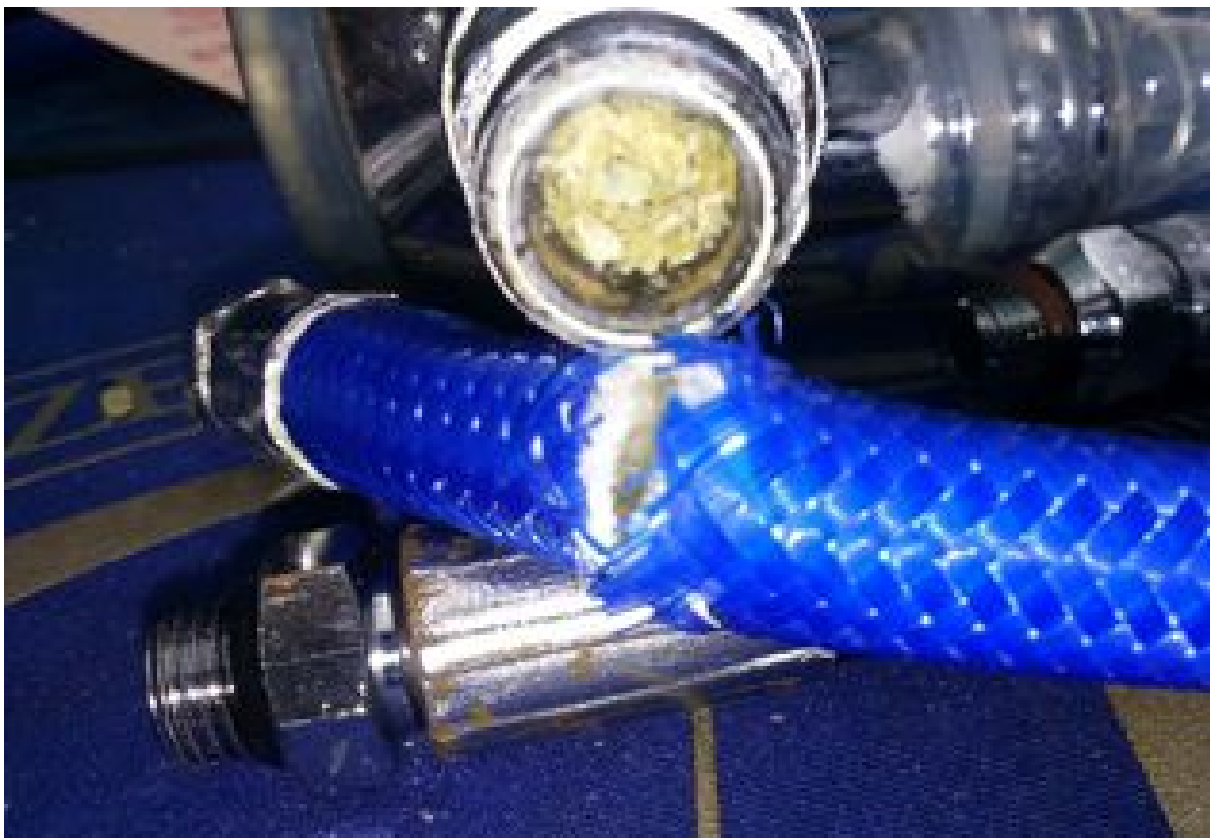
*Above: 'Polymorphic crystallisation' inside nylon-braided hoses and inside a regulator. Regulator picture courtesy of Cozumel SCUBA Repair. Pictures published with permission of the photographers.*

An analysis of the 'culprit' revealed it to be a form of 'polymorphic crystallisation' - a phenomenon associated with cyclical heating and cooling at oil-water interfaces(3). In both these cases, the crystallization seemed to be related to the molecular structure of the internal tube. The present theory is as follows: repeated cyclical heating and cooling of the internal

lining promotes this form of crystallisation in materials either unsuitable for this application, or affected by certain chemicals or bacteria. The sun heats the hose, whereas the flow of expanding breathing gas cools the internal surface of the hose down again. This process recurs with each dive, and the crystals grow and accumulate over time. Eventually, enough crystals form to encroach on the flow of gas, or they migrate towards the second stage regulator, resulting in significant failure of the breathing device.

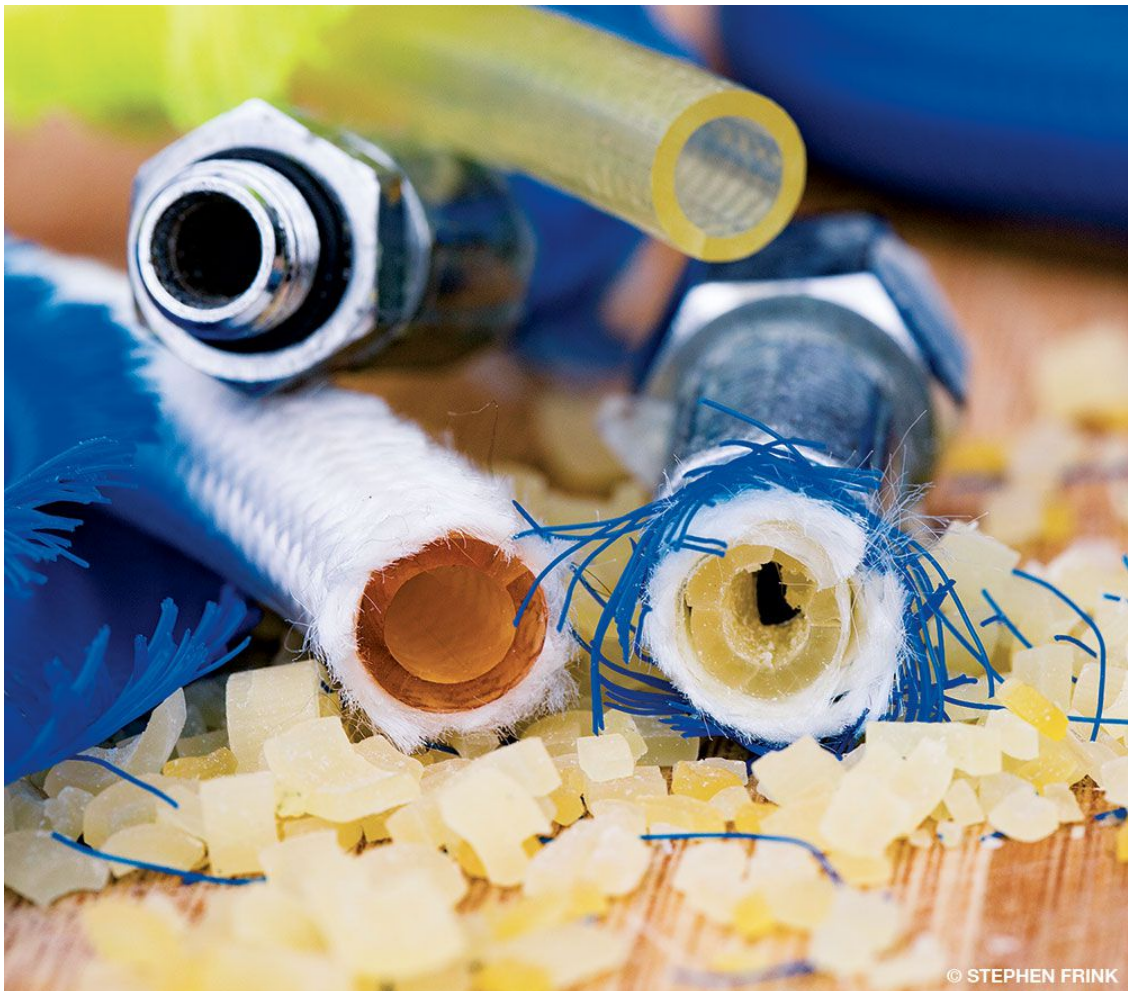
Polymorphic crystallization inside hoses has recently emerged as a hazard divers should be aware of.

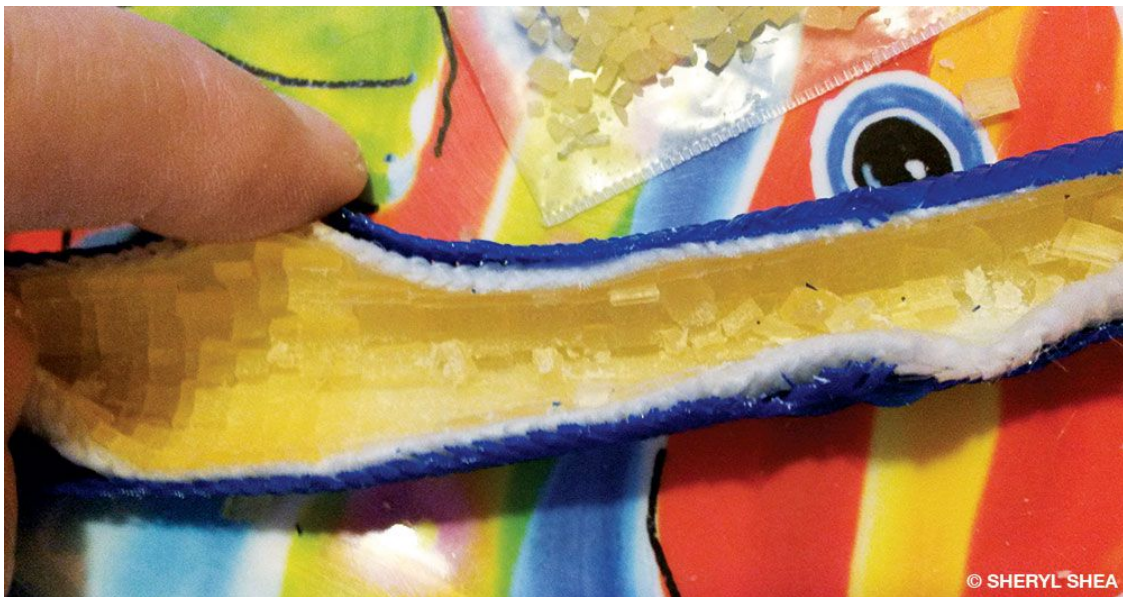
This open hose shows the extent of degradation.
